## Case Study: Point Walter Foreshore Restoration

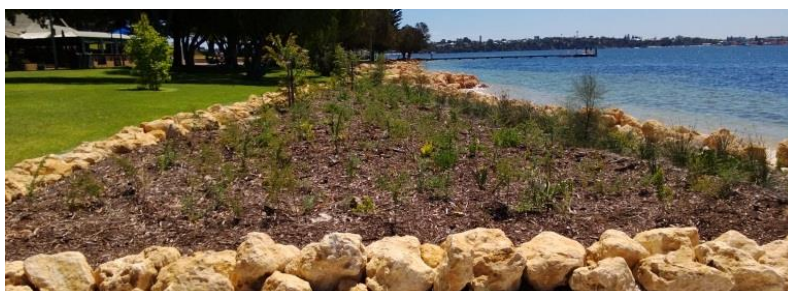
Initial works commenced in March 2012 and included regrading, removal of some non-endemic trees and rock work. Gabion cages were installed to help prevent further loss of grassed areas and brush-matting was placed along some lengths of the foreshore. Several timber decks and seating elements were installed to provide access and amenity to the general public. New turf was installed and is watered by an extensive irrigation system. A gross pollutant trap was also installed to prevent pollutants entering the River from the car park areas.

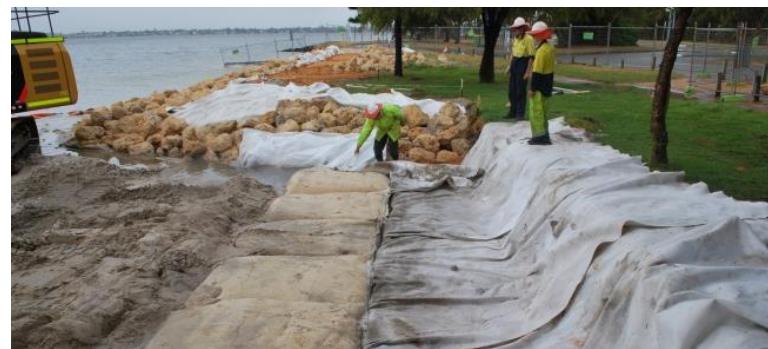
NAMS worked with a consulting marine engineer to develop a plan to mitigate high levels of erosion in one of the restoration zones. The plan involved the installation of rock armour and Geosynthetic Sand Containers (GSC's) over three nodes as well as some clearing, trimming and filling to create a suitable gradient for the site.

Elcorock GSC's were filled on site and positioned using a 1.8 t excavator. Rock armour; being limestone rock boulders up to 0.5 tonnes each were also positioned using the 1.8 t excavator. NAMS supplied and installed all materials and equipment for the project including the excavator. The biggest issue at the site was depth to groundwater and working in waterlogged conditioned whilst trying to position geofabric, rock and GSC's.
