Case Study: Walter’s Brook Restoration

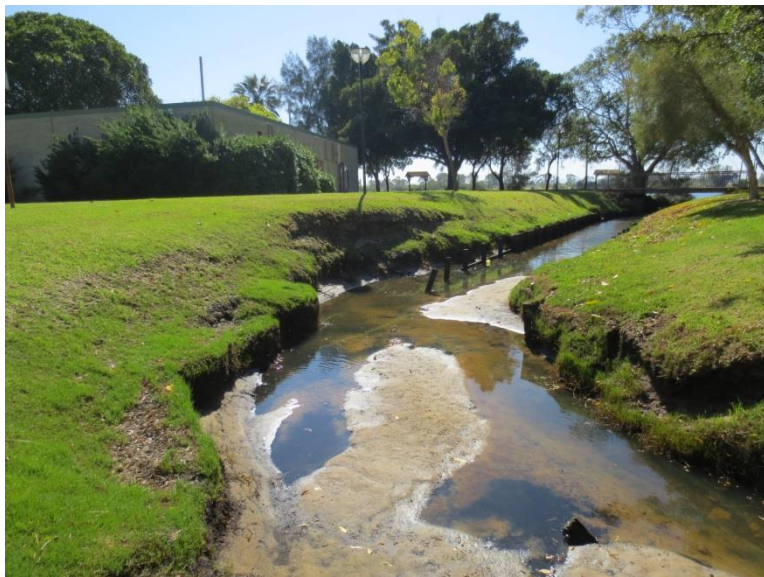
▲ October 2013: Initial site conditions

Natural Area was contracted by the City of Vincent to undertake planning, design and on ground restoration works at Walter’s Brook, Banks Reserve. The brook had become degraded due to large sediment deposits washing in from drain outlets and severe bank erosion due to inappropriate alignment of the drainage channel (*pictured above*).

On-ground works followed restoration plans designed by Natural Area and Urban Serenity in 2013. Erosion in the area was mitigated with a combination of soft and hard engineered techniques. Straightening of the drainage channel with the installation of gabion walls and gabion mattresses to diffuse the impact of running water through the channel, thus reducing bank erosion. The installation of limestone spillway at the drain outlets, around the bridge and along the toe of the channel will help to reduce the impact of water flowing through the channel during high rainfall events. Sections of the bank were recontoured to create a low gradient slope; these banks have been covered in a biodegradable erosion control matting to prevent the establishment of weeds and to temporarily stabilise the soil whilst revegetation works establish. The maturation of these plants will help to stabilise the bank once the matting has deteriorated.

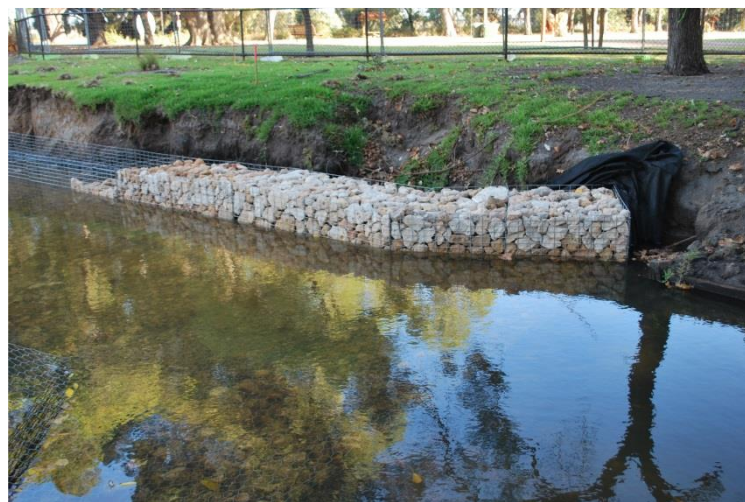
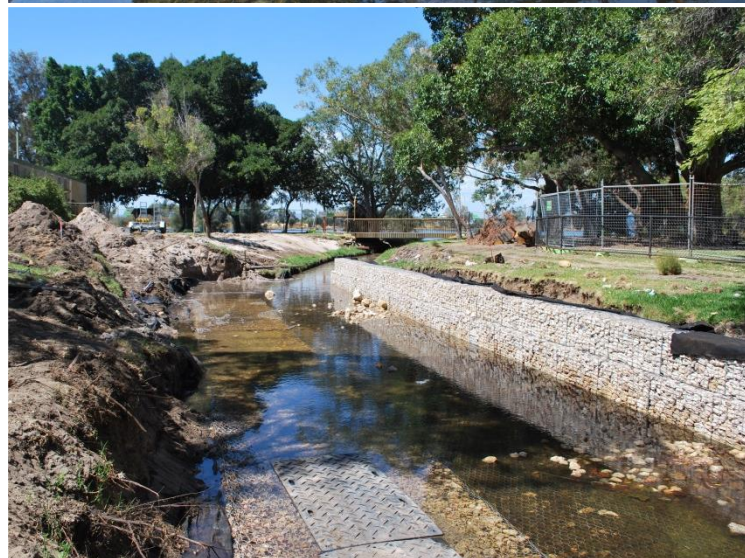
▲ March 2014: Installation of gabion wall

- ▶ removing excess sediment from the channel
- ▶ recontouring the banks to create a suitable gradient
- ▶ installation of gabion walls and mattresses into the channel to mitigate erosion
- ▶ installation of a limestone spillway
- ▶ temporary fencing
- ▶ revegetation planting.
